Manhole Inspection Summary

Manhole # S09II2018MH

Location Address: **6317 GREEN MEADOW PKWY** Cross Street: **EDENVALE RD**

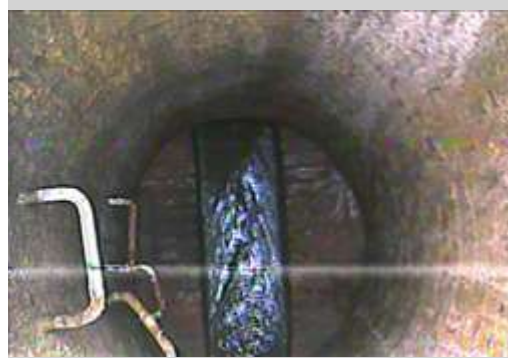
Top View

Barrel infiltration. Corroded steps. Bench debris.

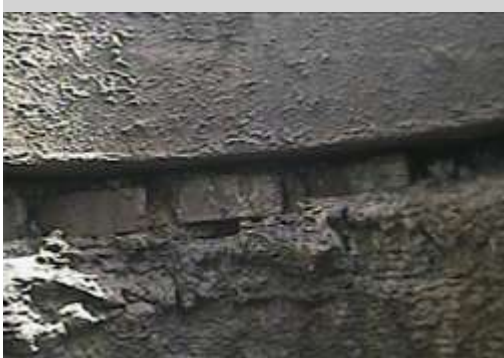
Defect

Frame leaks. Adjustment deterioration and infiltration.

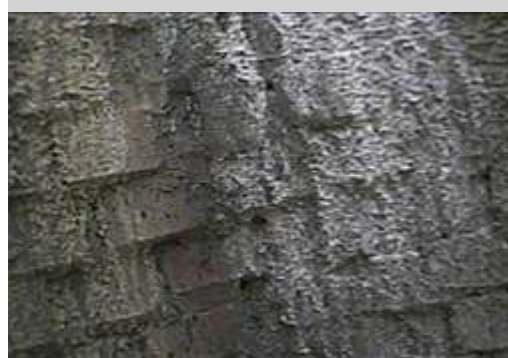
Defect

Mineral deposits.

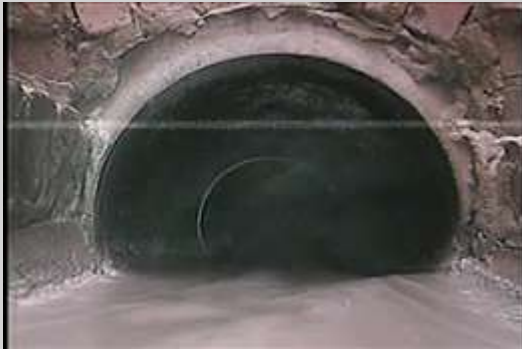
15 in. Circular Gravity Sewer Pipe Out @ 12 O'Clock

Rod and Bar (Angled)

Infiltration: **None** Pipe Seal Cond: **Unknown**

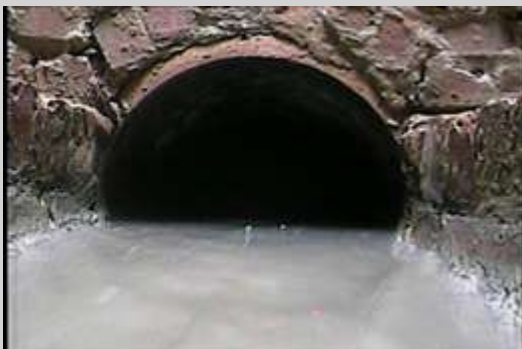
15 in. Circular Gravity Sewer Pipe In @ 6 O'Clock

Rod and Bar (Angled)

Infiltration: **None** Pipe Seal Cond: **Unknown**
